# NBS SPECIAL PUBLICATION 400-70

*Semiconductor Measurement Technology:*

## The Use of Acoustic Emission to Determine the Integrity of Large Kovar Glass-Sealed Microelectronic Packages

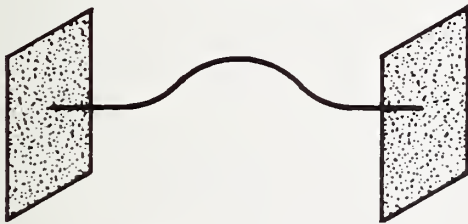
$$\text{at } y = 0, \frac{dy}{dx} = 0$$

Figure 1. Sketch of "fixed" boundary conditions.

The three boundary conditions appropriate to PC boards are "fixed," "supported," and "free." For the fixed conditions, sketched in figure 1, the board edges are firmly clamped such that the edge motion is zero and the tangent is also zero. The term "supported" (also referred to as "simply supported" or "freely supported") is a carryover from beam-bending theory where the ends of the beam are supported on knife edges. For a PC board, each edge is considered supported on top and bottom between two knife edges. In this case, motion at the edge supports is zero but the tangent is not constrained, as shown in figure 2.

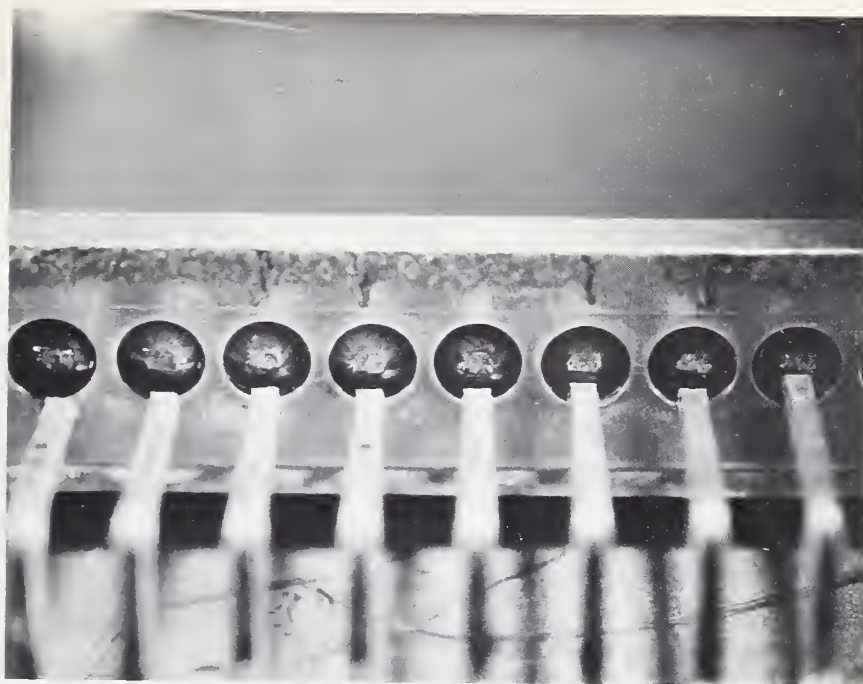
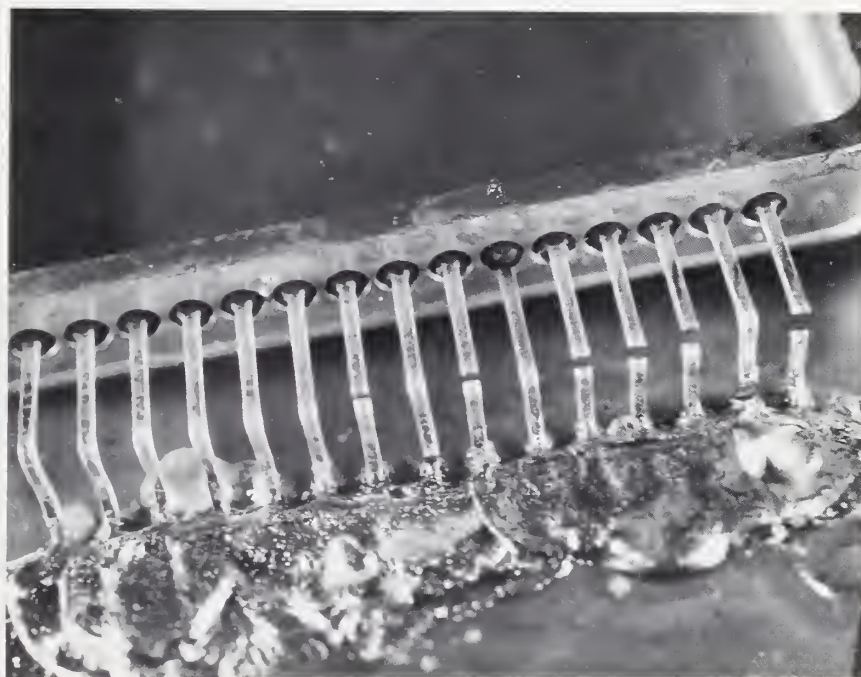
Figure 8. Photomicrographs of a 1-in. square hybrid package after vibration testing. (a) Leads fatigued off during vibration tests at the package seals, showing glass damage. (b) Leads fatigued off at the bends or at the solder joints.

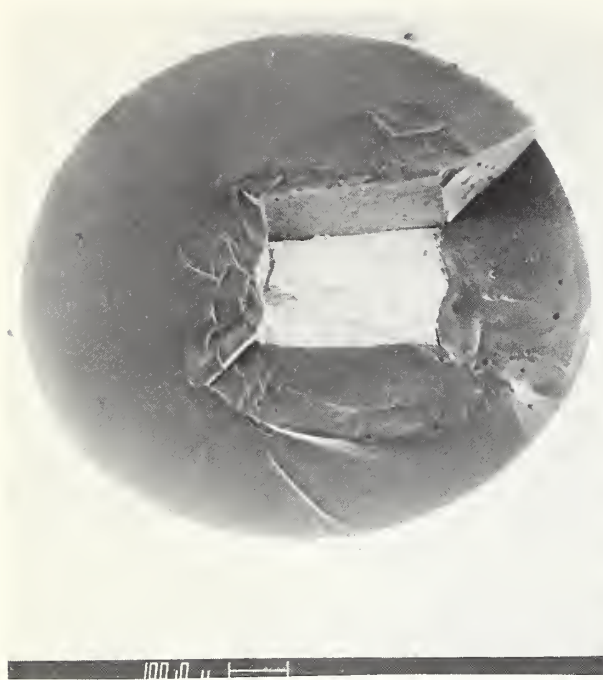
Figure 13. SEM photomicrographs of glass-metal seals in hybrid packages that have been vibrated. No hermetic damage occurred to the packages. (a) and (b) Seals from packages vibrated at 200 and 300 g at 250 Hz. (c) Seal and lead from a package vibrated at 80 g at 260 Hz. The small dots on the glass portion are foreign particles and not a part of the seal.

Experiments were performed to determine whether seal damage in high-quality packages could be induced when the leads were fatigued off rapidly and violently at high-g levels. Two flatpack packages were soldered onto a PC board symmetrically, near the center, and vibrated at 200 to 300 g for several minutes until all of the leads of one package fatigued off and the package fell from the board. The other package remained on the board held by three or four (out of 30) leads. Figures 13a and 13b are scanning electron microscope (SEM) micrographs of two of the severely damaged but still hermetic seals! Figure 13c is included from an earlier vibration run at a lower stress level (~80 g for 10 min). All of the packages were tested for leaks at room temperature and at 125°C and found to be better than  $10^{-7}$  atm $\cdot$ cm<sup>3</sup>/s. An important conclusion of this experiment was that no correlation was observed between the visual appearance of the seal and leaks when high-quality packages were studied [37].

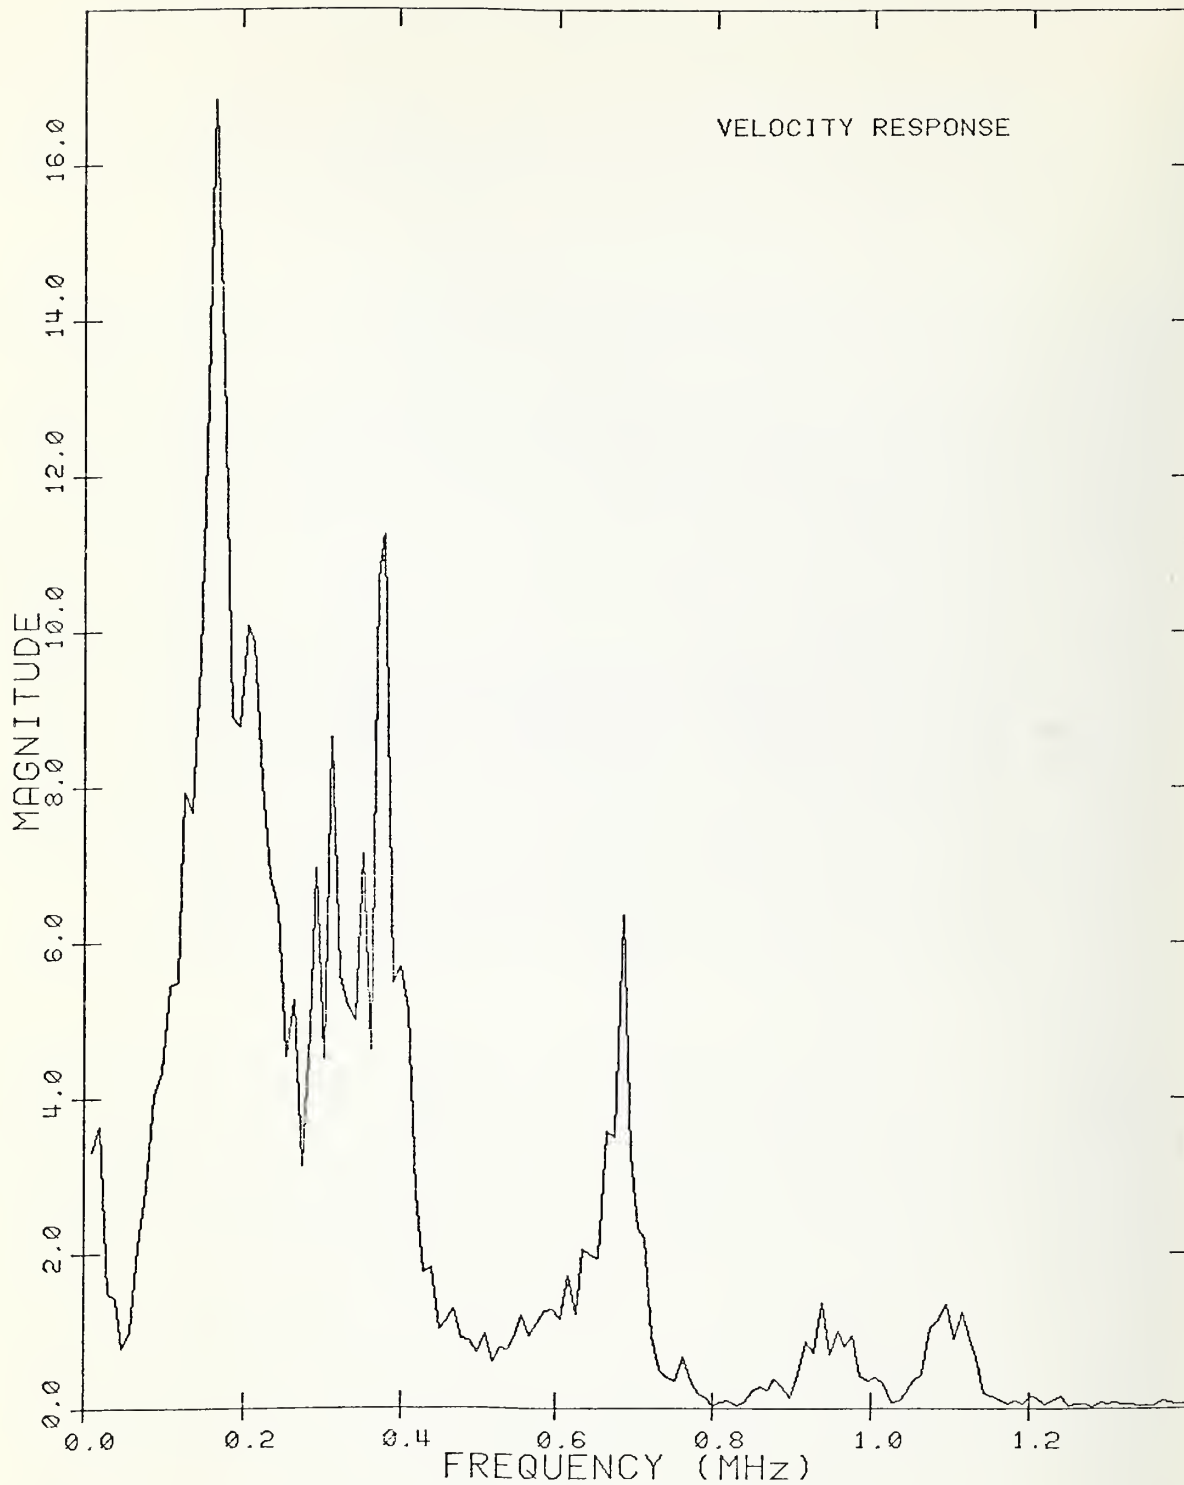
Figure 15. The frequency spectral response of a TO-100 acoustic-emission detector-preamplifier. (The PZT ceramic element used in this test was designed for a 1-MHz peak response.)

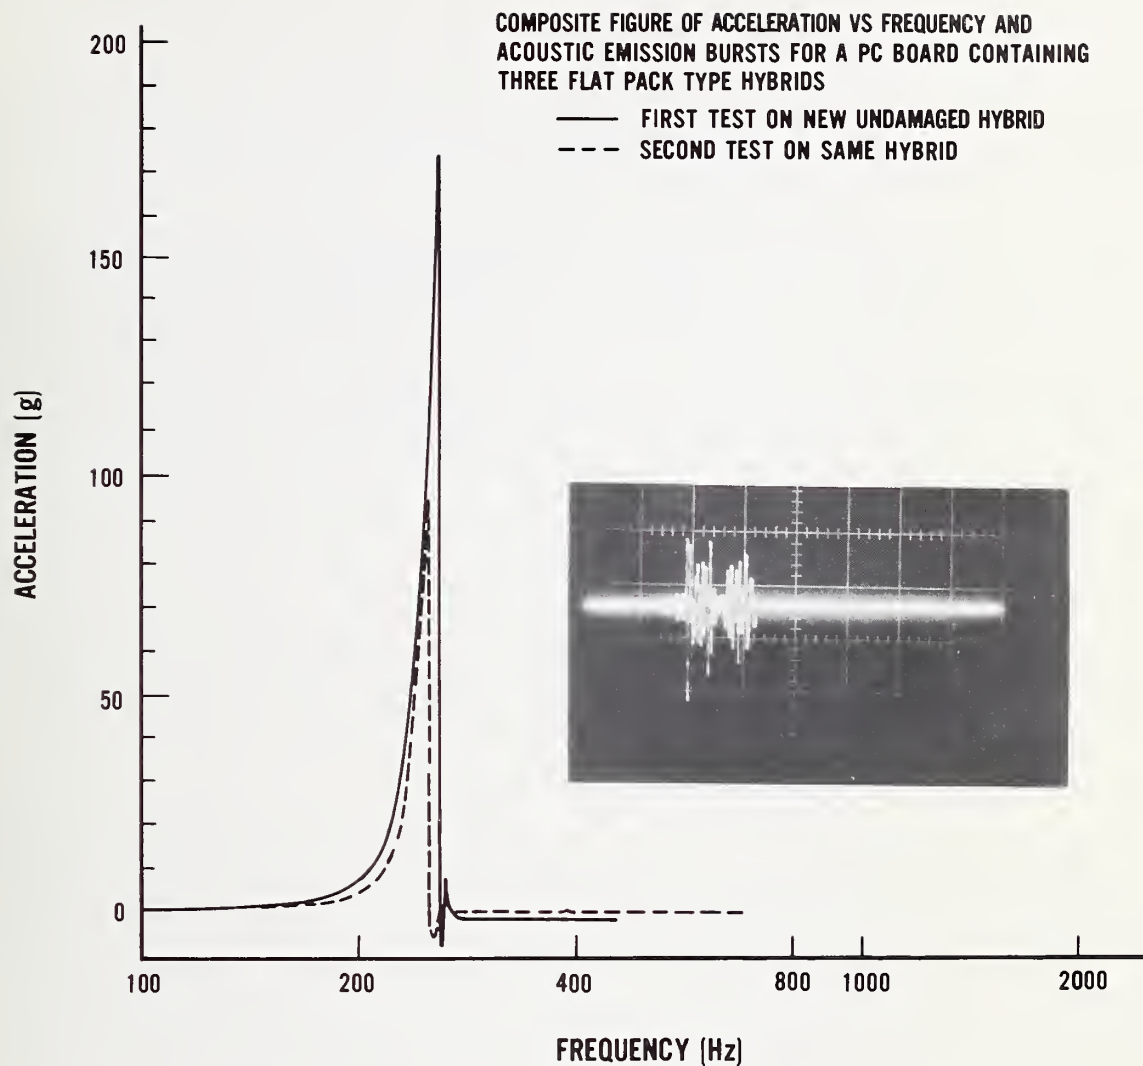
Figure 22. Composite of the acceleration experienced by a flatpack hybrid and the acoustic-emission burst emitted at the peak acceleration of the solid curve. The instrumentation turned off the vibration shaker drive when the burst was received, so the acceleration dropped to zero at that time.

Figure 22 is a composite of the x-y recorder curve tracing showing the acceleration experienced by an initially good package (no glass cracks by visual inspection) as it was scanned through its frequency spectrum until a glass crack occurred. The photographic insert shows the acoustic-emission burst that occurred at the peak acceleration. The acoustic-emission trigger removed the shaker drive, and the acoustic-emission burst was simultaneously recorded by the transient recorder (see fig. 19). After this first glass cracking occurred in the essentially perfect package, further runs produced AE bursts at lower accelerations, in the order of 1/3 to 1/2 that of the first run. Equivalent tests were also made with intentionally damaged packages. In no case during these experiments did the acceleration ever reach levels higher than 40 to 50 g before acoustic-emission bursts occurred. After the AE tests, all of the packages were tested on a helium leak tester, and even though glass cracking had occurred, there were no hermetic leakers.
